# Manhole Inspection Summary

Manhole # S21I\_\_004MH

Insp Date: **9/24/07 11:07 AM**

**Location** Address: **1632 FREDRICK AVE**

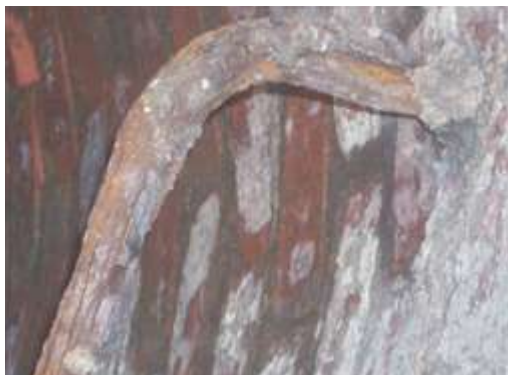
Defect 4

Infiltration: ☐ None ☐ Joint ☐ Cracks ☐ Mortar ☐ Roots ☒ **Wall**

INFILTRATION OF CORBEL WALL  
NEAR STEP

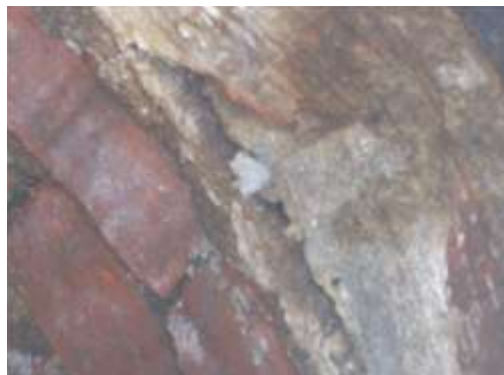
Defect 3

Condition: ☐ Sound ☐ Cracked ☐ Root Intrusion ☐ Loose Brick ☒ **Deteriorated**

CHIMNEY DETERIORION

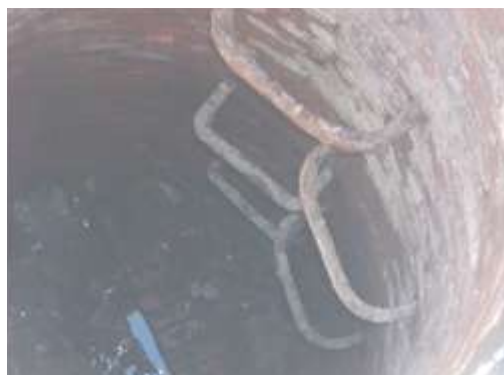
Defect 1

Count: **5** Missing: **0** ☒ **Corroded**

CORRODED STEPS

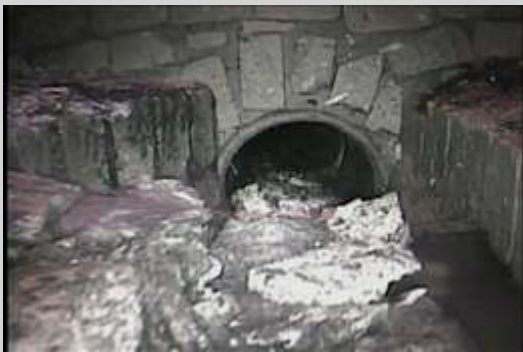
12 O'Clock Outflow

Pipe Height: **8.4** (in.) Rod and Bar (Angled)  
Pipe Material: **Clay** ☐ Pipe Lined  
Invert Depth: **12.41** (ft.) Flow Characteristics: **Slow**  
Deposits: ☐ None ☐ Mud ☒ **Sludge** ☐ Debris ☐ Grease  
Silt Depth: **4** (in.) Deposits Extent: **Medium**  
Infiltration: **None** Pipe Seal Cond: **Sound**

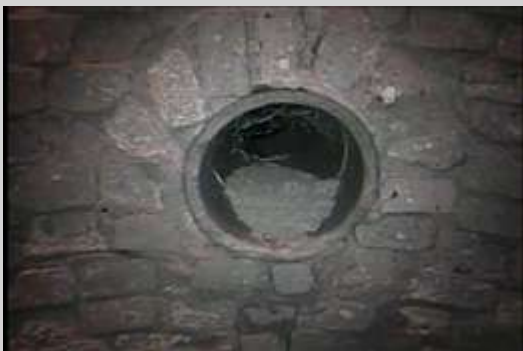
6 O'Clock Inflow

CHIMNEY DETERIORION

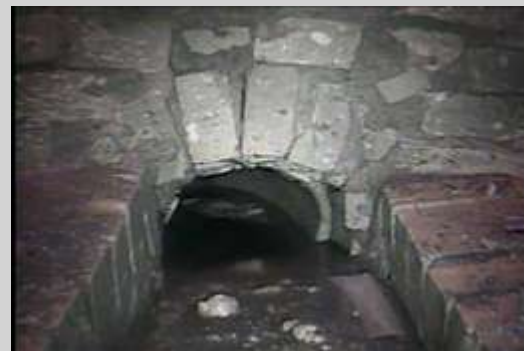
Drop In @ 6 O'Clock

CHIMNEY DETERIORION

Pipe Height: **8.4** (in.) Rod and Bar (Angled)  
Pipe Material: **Clay** ☐ Pipe Lined  
Invert Depth: **10.73** (ft.) Flow Characteristics: **Slow**  
Deposits: ☐ None ☐ Mud ☒ **Sludge** ☒ **Debris** ☐ Grease  
Silt Depth: **1** (in.) Deposits Extent: **Light**  
Infiltration: **None** Pipe Seal Cond: **Sound**

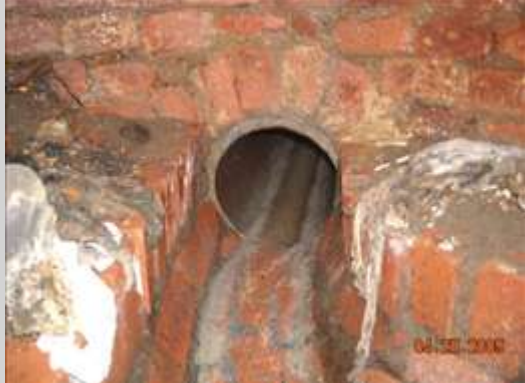
9 O'Clock Inflow

Deposits: ☐ None ☐ Mud ☒ **Sludge** ☒ **Debris** ☐ Grease

Silt Depth: **8** (in.) Deposits Extent: **Heavy**
